07/13-2001 - Utrecht Netherlands – William T Brewer - FF PSD - Training

Diving Accident Key Haven – Netherlands

Diving Accident Key Haven July 13, 2001 - Firefighters City of Utrecht

November 2001

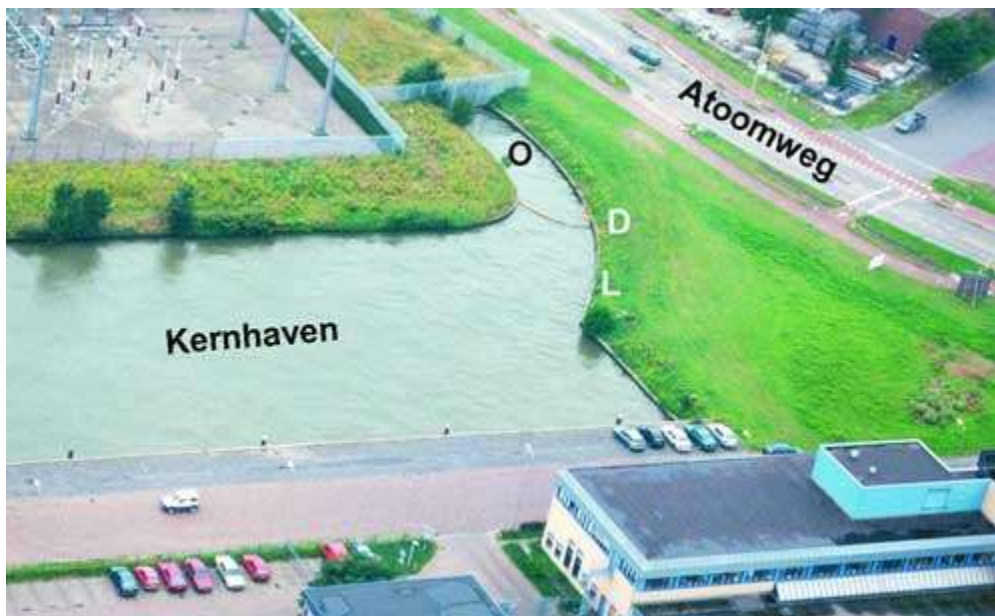
- * O - global positioning accident
- * D - site diving supervisor at dirt removal
- * L - Ladder / start exercise

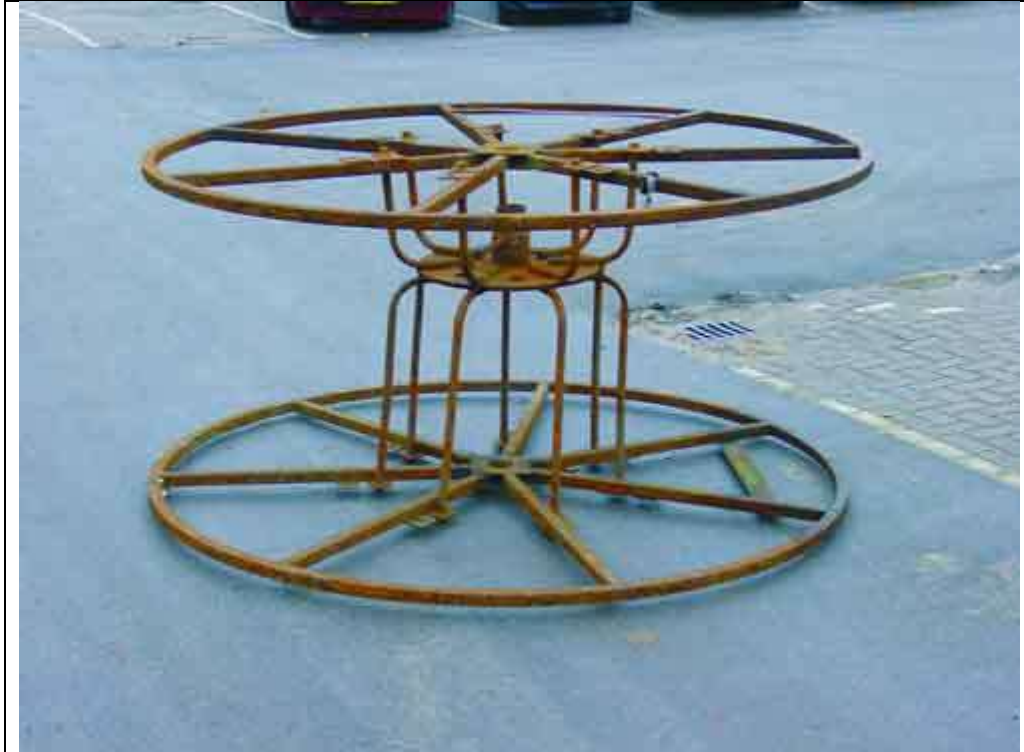
Fig 2 The Reel

- * Large, unidentified concrete objects;
- * A large metal cable reel (diameter 2.25 m, height 1 m) (see Figure 2);
- * A metal pipe (diameter 7 cm, height 4 m) protruding obliquely upwards in the direction of flow, apparently because he was resting on other obstacles, and not because he was stuck in the (concrete) floor;
- * Close to the reel diving knife which was lost in the rescue attempts one of the divers.

In the final phase of the accident touches the line loose from the soil, and is, perhaps by the flow, back through the reel. It is certain that the line after it is exhausted is tightened at some point. Eventually William is located in the reel with line taut to colleagues on the side.

11. The reel found was examined and photographed. An experiment showed that a large man with a SCUBA unit without any problems through the openings in the cheeks of the reel (diameter 2.25m height 1m) could pass.

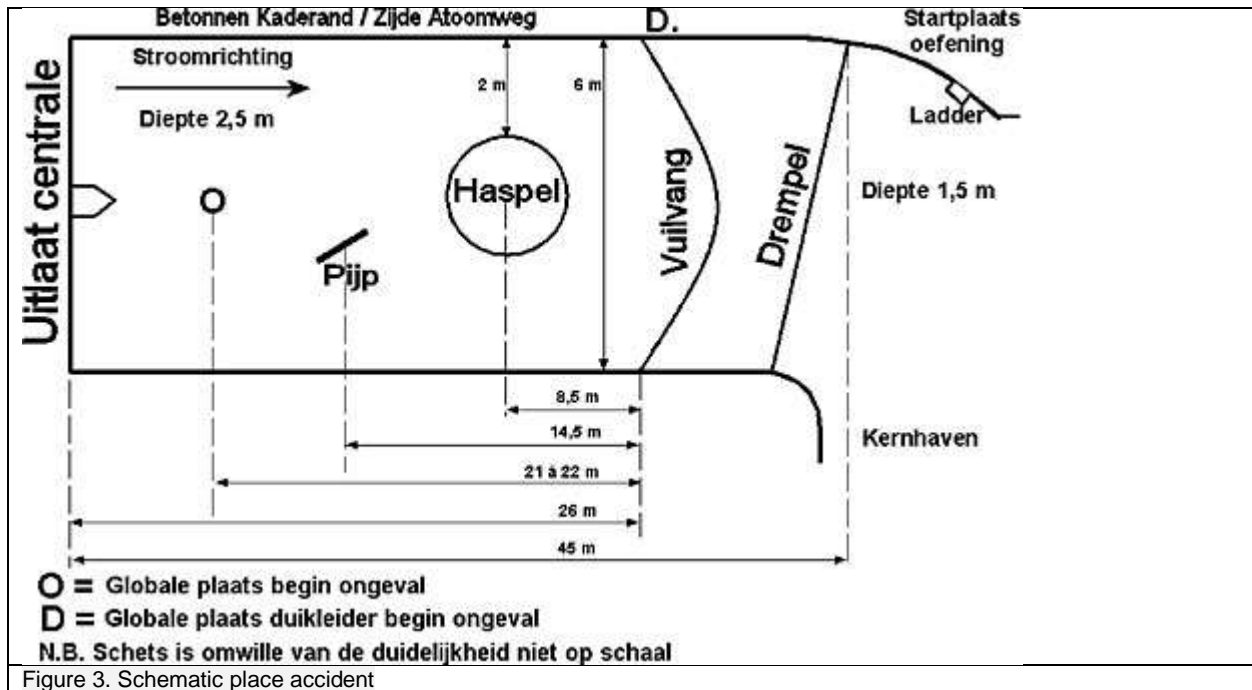
Figure 3. Schematic place accident

Shortly before the exercise he puts on his diving gear and once again checks his equipment (visual and taste breathe). The duikploegleider ordering him to be from the ladder (see Figure 3) on the bottom and

along the quay wall to the outlet of the central swimming and after terugtochtsignaal (three stools after attentiesein) along the same path back to return.

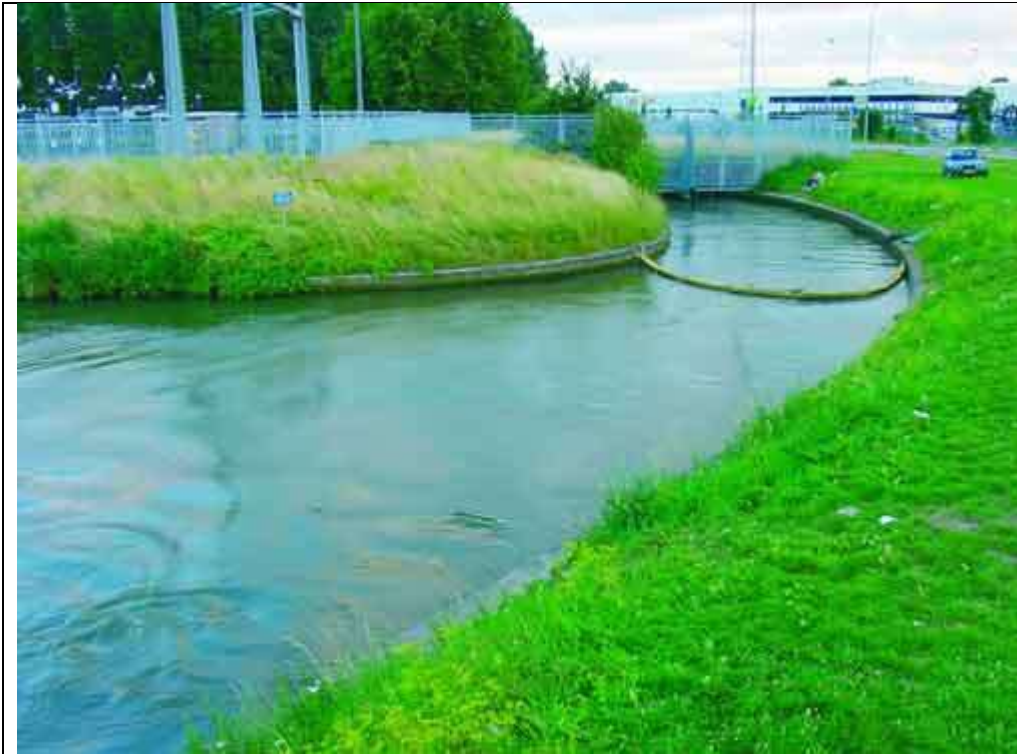
On the threshold that is present in the channel is not more than noted that there is a "difficulty" is in the approach route. In any case, one explanation that this exercise does not always advance attention was paid to the way in which had to be returned (with head in the direction of flow). It is not impossible that William was not informed in advance about this way of return.

Figure 4 General view site accident. The swirls at the surface are a clear indication of the location of the threshold.

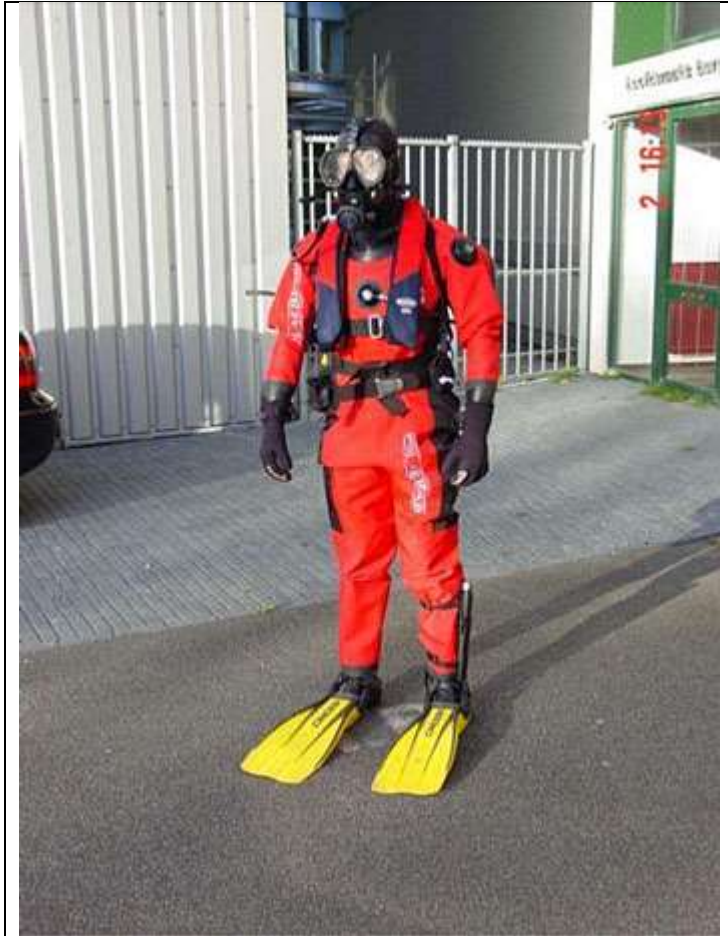
With a total test by the Navy proved the equipment to operate without problems, although the full face mask on a test depth of 21 meters, in certain positions (lying on the back and head down) water to leak inside. Thereby, in the fact that head shaking did not affect, concluded that the harness 'was good'.

Figure 5 A diver in Utrecht operational equipment
