01-15-2000 Roanoke NC - Gary Lynn Bankert SR – FF PSD Training

Volunteer Fire Fighter Drowns During Dry-Suit Training Dive - North Carolina

SUMMARY

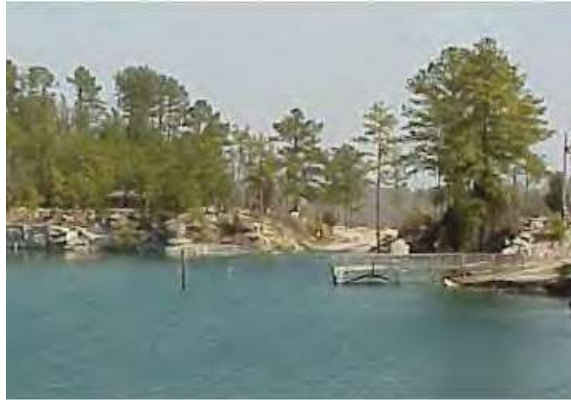
Incident Scene

On January 15, 2000, dry-suit certification training was being conducted by a local commercial dive shop at a private freshwater lake. The lake is an old rock quarry that is approximately 100 acres in size with a maximum depth of 65 feet. Dedicated exclusively to recreational diving, the lake has a number of underwater sites that include sunken boats and training platforms. These dive sites are marked with surface buoys and are tethered by guidelines (3/16-inch nylon rope). The water clarity on the day of the incident was 12 feet. The surface was calm and the water temperature was 51° F. The weather conditions were reported as sunny with an ambient air temperature of 48° F. The training consisted of a 3-hour classroom training session held on January 8, 2000, followed by three open-water dives that were conducted on January 15, 2000. The class began at 0800 hours with the first three hours consisting of setting up air bottles, checking equipment, and pre-planning of scheduled dives. Three dives were planned for that day ([see Diagram 1](#)). The instructor and five divers buddied up to form three teams of two divers each. The class began the first dive at 1100 hours in an area near shore at a depth of approximately 12 feet. This session allowed the students to do the following: (1) become familiar with their dry-suits and dry-suit buoyancy, (2) ensure that air could be relieved from their dry-suits to prevent over inflation, (3) adjust the weight on their weight belts, and (4) conduct pivot maneuvers. The victim needed to add approximately 10 pounds of additional weight to his weight belt, bringing the total weight to approximately 18 pounds, to compensate for the added buoyancy of his dry-suit. The first dive lasted approximately 30 minutes. The divers then took a 1-hour break on shore where they consumed water and soft drinks. They donned new air bottles prior to the second dive. (Air bottles were filled to an approximate air pressure of 3,000 psi before each dive.) The second dive lasted 25 to 30 minutes and was conducted in 20 to 25 feet of water. The second dive consisted of following the sloping bottom down, moving away from shore, and then traveling parallel to the rock wall leading out toward a buoy tethered to a sunken boat. The victim, for an unknown reason, became separated from the group at this point but was located at the surface by the instructor. The victim indicated to the instructor that everything was alright, and the two proceeded back down to join the group. The group followed the tethered guideline down to the boat (depth approximately 20 feet) where they conducted skills training maneuvers. The group ascended the line toward the surface where they made a 3-minute safety stop at a depth of 15 feet. The group then surfaced, went to shore, and took another 1-hour break before proceeding with the third dive. The third dive consisted of swimming on the surface to the same buoy where they had conducted their second dive. Once they reached the buoy they began their dive by descending the guideline to the bow of the boat. A second guideline is tethered from the bow of the boat (at approximately a depth of 20 feet) to a training platform 350 feet from the boat (at a depth of 28 feet) ([see Diagram 2](#)). Once the group reached the bow of the boat, they followed the second guideline toward the platform for another 100 feet (at a depth between 20 and 28 feet) before stopping. The divers then spent approximately 20 minutes performing various training tasks before proceeding side-by-side along the guideline in

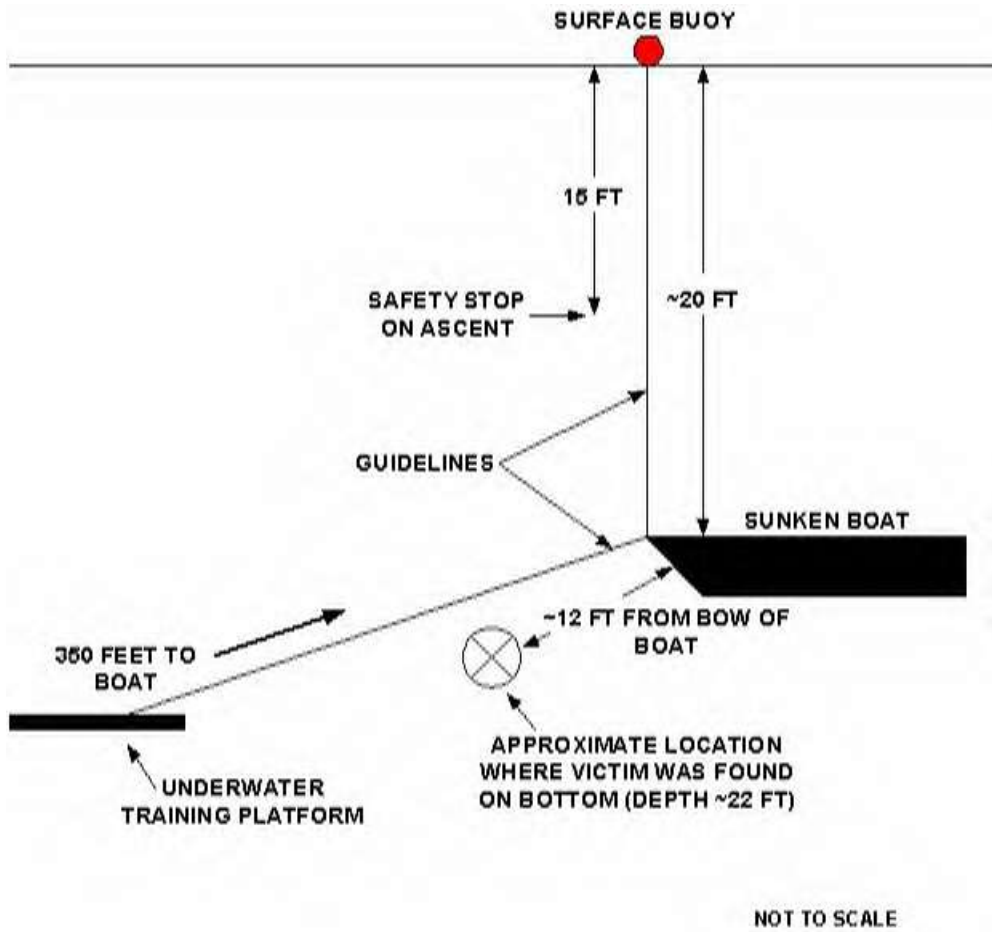
Diagram 2. Profile of Incident Site

teams of two back toward the sunken boat. They ascended the guideline from the bow of the boat toward the buoy on the surface and completed a safety stop with the instructor at a depth of 15 feet. The divers were in a circle facing each other with the guideline in the center of the circle. After a 3-minute safety stop, the divers gave an okay signal to the instructor to continue their ascent to the surface. The victim was last seen slightly below and to one side of his partner at a depth of 8 feet and appeared to be ascending without difficulty. All of the divers made it to the surface simultaneously except for the victim. The instructor and students did not see any air bubbles breaking the surface. The instructor told two of the students (one a dive master and the other a certified search and recovery diver) to follow the guideline back down and retrace the dive path along the guideline. The instructor and one of the students then swam to shore to find a vantage point from where they could locate the missing diver by looking for his air bubbles breaking the water surface. Once they reached shore (approximately 40 feet from the buoy) they looked for but did not see any air bubbles. The instructor told the student to go dial 911 at a phone located nearby. The two divers reached the bow of the sunken boat and found the victim's snorkel (approximately 8 feet from the boat) on the bottom near the guideline. (The victim had put his snorkel in his Buoyancy Compensator Device [BCD] because it had broken off earlier during the training exercise.) The two divers then began following the line leading from the bow of the boat toward the training platform. Approximately 12 feet from the bow of the boat, they found the victim in a sitting position on the lake bottom (at a depth of approximately 22 feet) with his mask still in place but without his regulator in his mouth. The two divers immediately put air in the victim's BCD and ascended to the surface. The entire descent and ascent took approximately 1½ minutes. Once the divers reached the surface with the victim, they established buoyancy for themselves and the victim, and then they cleared vomit from his mouth. They removed the victim's mask and noticed a small trickle of blood emitting from his nose. They began rescue breathing and started moving him to shore. The victim did not have a pulse, and once on shore the divers began administering cardiopulmonary resuscitation (CPR). The paramedics arrived just as they were beginning the second chest compression. The paramedics finished removing the victim's equipment and cut off his dry-suit. They defibrillated the victim and then loaded him into the ambulance. The entire sequence from the time the victim was found on the lake bottom until he was transported to the hospital was approximately 6½ minutes. The victim was transported to a local hospital where he was pronounced dead 6 hours later at 2238 hours.
