08-10-2012 Sugarcreek OH – Michael Burgan – FF PSD Training

Volunteer Captain Dies While Participating in Advanced Dive Training at Quarry—Ohio

Death in the Line of Duty...A summary of a NIOSH fire fighter fatality investigation

F2012-25 Date Released: August 20, 2013

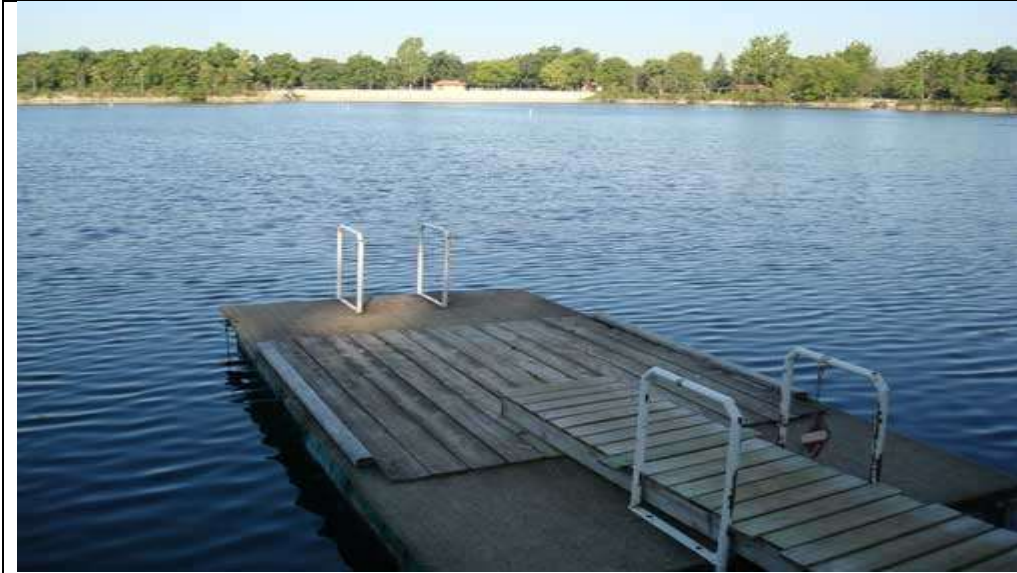
**Dock where victim was pulled from quarry.
(NIOSH Photo)**
