**Pvt. Warren J.C. Smith**  
**August 13, 2000**  
**Indianapolis Fire Department**

A summary of a NIOSH fire fighter fatality investigation

May 3, 2001

## **Fire Fighter/SCUBA Diver Dies During Training Evolution—Indiana**

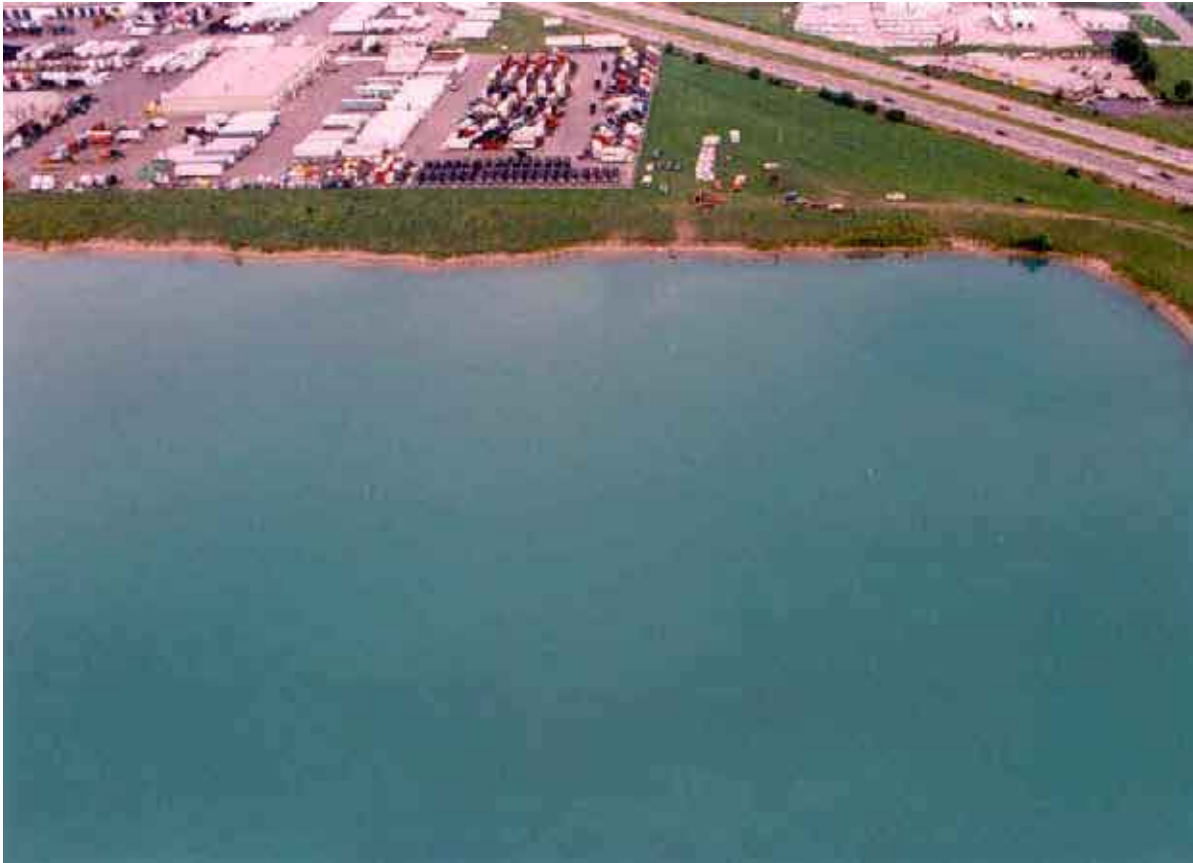
*Photo. Incident Site*

place was a large, open lake with depths near 100 feet ([see Photo](#)). The weather on the day of the incident was reported to be sunny, with the temperature in the mid-80 degrees, and calm winds. The water's visibility was reported to range from 0 to 10 feet. The water temperature was not recorded, but it did not appear to be a factor in the diver's performance. *Note: Although the water temperature was not recorded, interviews revealed that the water temperature was approximately 55 degrees.*

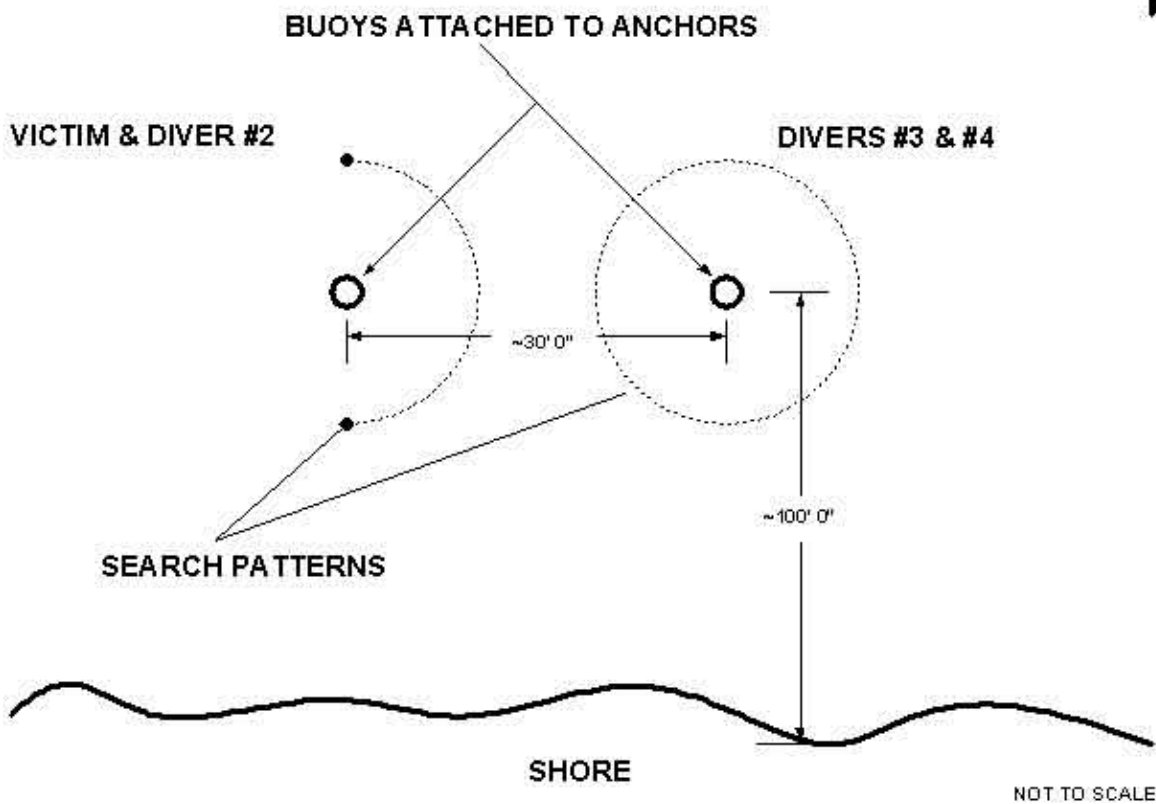
*Diagram. Search Patterns*

Any time rope lines are used underwater during SCUBA activity, the risk of entanglement is present. Rope lines used underwater should be kept at a minimum to avoid possible entanglement. When two different search patterns are being performed in close proximity, it is possible that the search patterns can overlap one another and cause the ropes to become entangled. If two different searches take place, they should be at a safe distance from each other and the proper staff should be assigned to oversee each individual dive operation. It is unclear that the search patterns were overlapped in this incident. However, Diver #3 located the victim underwater on his (Diver #3's) search line, which indicates that they had become entangled at some point underwater. Diver #3 recalled releasing approximately 40 feet of rope line during their circular sweeps. The buoys were set up approximately 30 feet from each other. Additionally, it was stated that the buoys were dragged from their original placement closer together during the operations, which also indicates entanglement of the two lines.

***Recommendation #2: Fire departments should ensure that underwater searches are completed individually to avoid possible rope entanglement.***
