**08-13-2000 Indianapolis IN – Warren Smith – FF PSD Deep Training
Barotrauma**

A summary of a NIOSH fire fighter fatality investigation

May 3, 2001

Fire Fighter/SCUBA Diver Dies During Training Evolution—Indiana

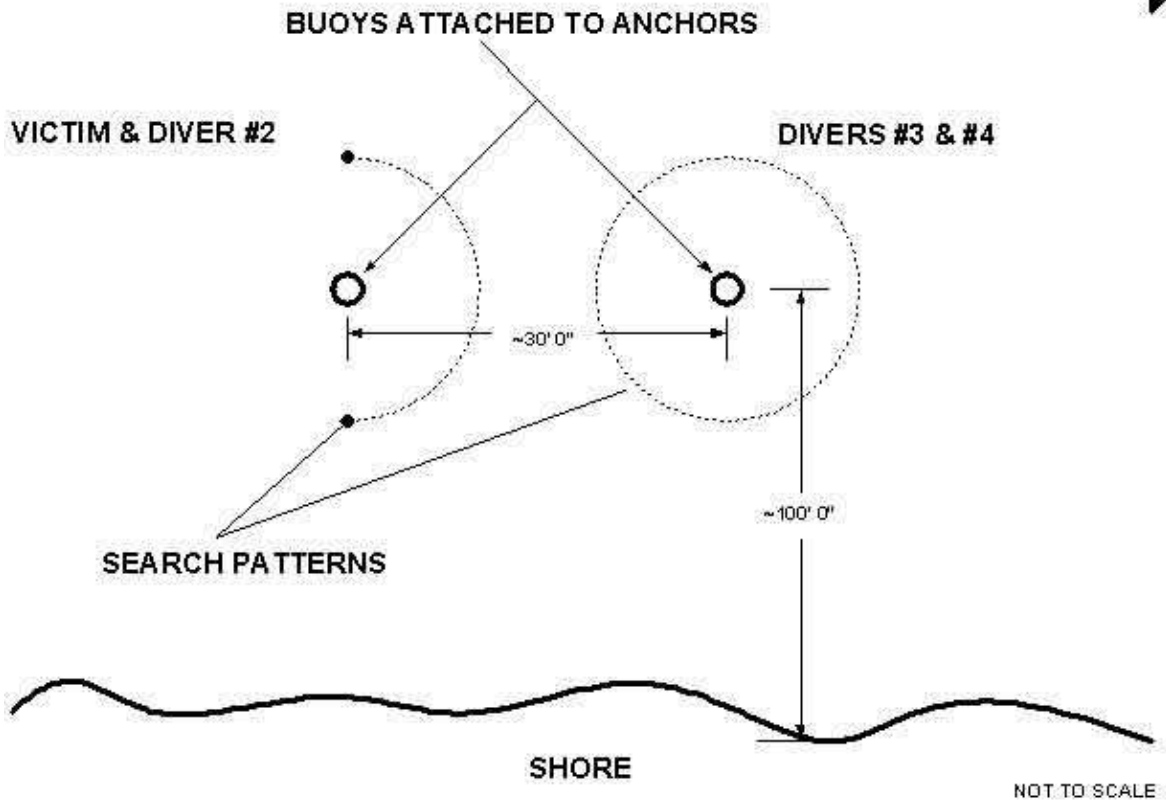
Diagram. Search Patterns

Any time rope lines are used underwater during SCUBA activity, the risk of entanglement is present. Rope lines used underwater should be kept at a minimum to avoid possible entanglement. When two different search patterns are being performed in close proximity, it is possible that the search patterns can overlap one another and cause the ropes to become entangled. If two different searches take place, they should be at a safe distance from each other and the proper staff should be assigned to oversee each individual dive operation. It is unclear that the search patterns were overlapped in this incident. However, Diver #3 located the victim underwater on his (Diver #3's) search line, which indicates that they had become entangled at some point underwater. Diver #3 recalled releasing approximately 40 feet of rope line during their circular sweeps. The buoys were set up approximately 30 feet from each other. Additionally, it was stated that the buoys were dragged from their original placement closer together during the operations, which also indicates entanglement of the two lines.

Recommendation #2: Fire departments should ensure that underwater searches are completed individually to avoid possible rope entanglement.
