08-17-2000 Denver CO - Robert Crump - FF-Flood -Trapped in Culvert

Firefighter's drowning prompts safety review

F2001-02
DIAGRAM
AERIAL VIEW OF INCIDENT SCENE

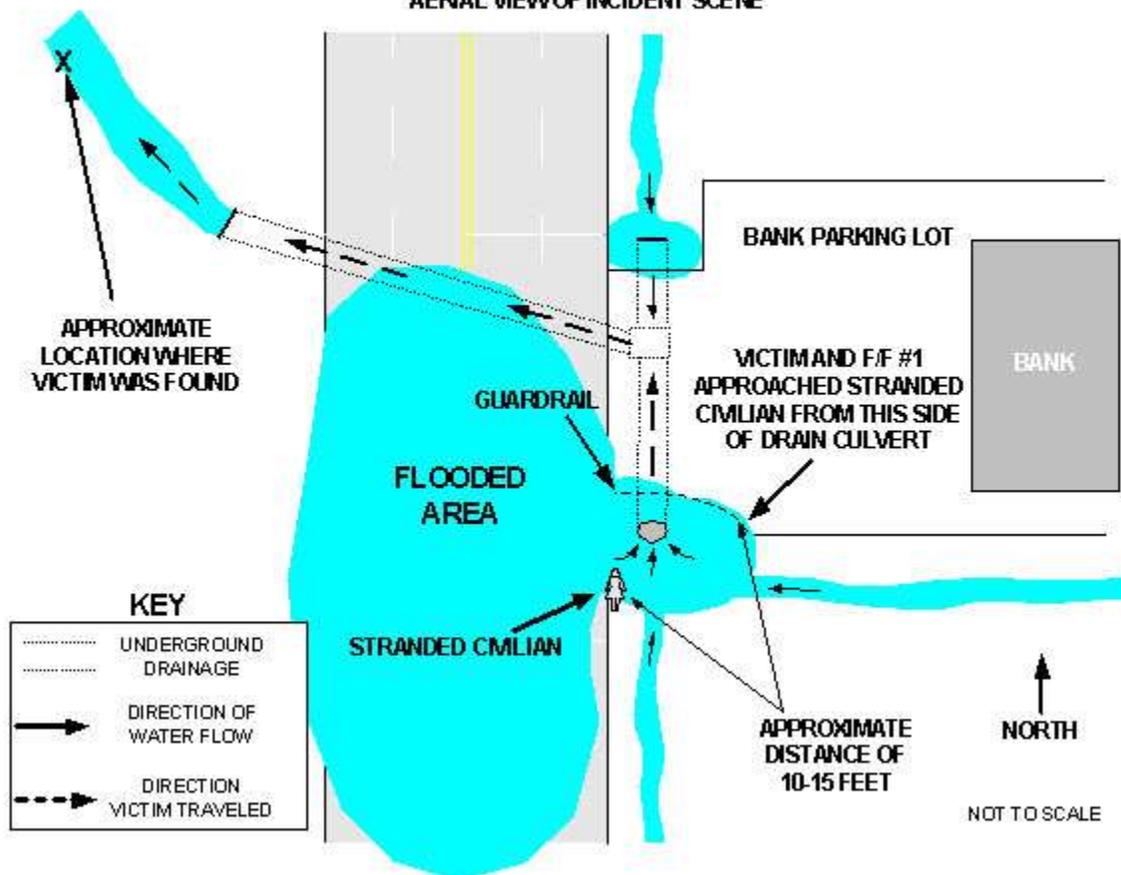
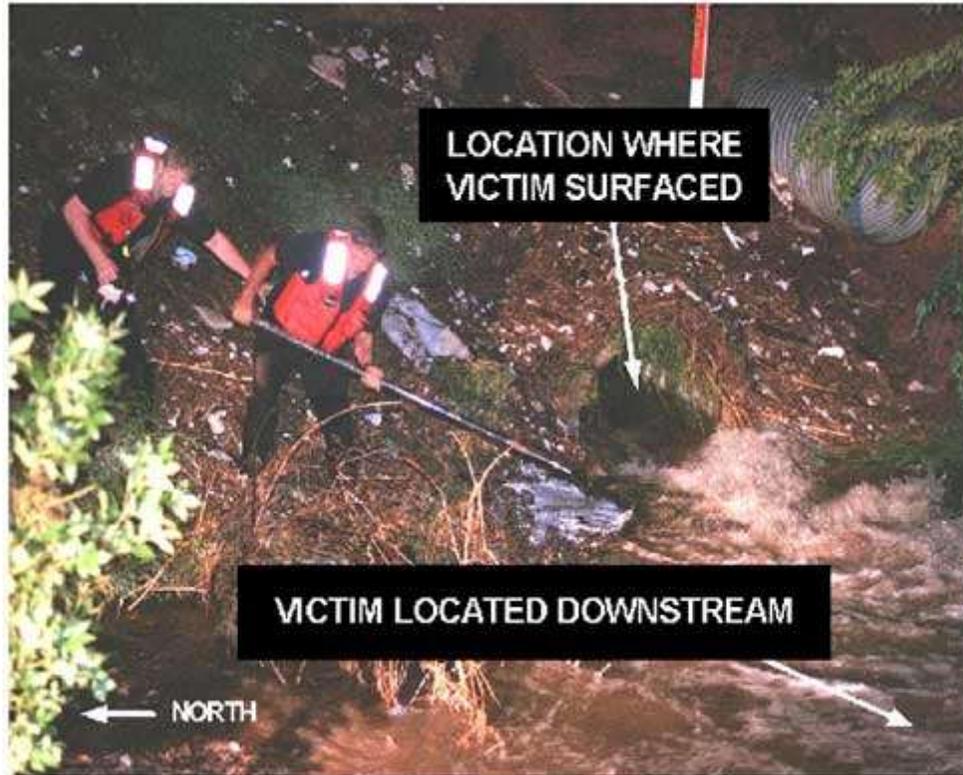
On the day of the incident, weather conditions were cloudy with severe rain and thunderstorms. The site of the incident consisted of a 4-lane divided boulevard, a 5-foot diameter culvert which feeds into a drainage system, and an underground cement vault measuring 10 feet by 8 feet. A drainage pipe, laid under the boulevard, measures approximately 5 feet in diameter. The exposed, open south end of the pipe lies within a large drainage ditch into which it empties. The bottom of the pipe at the inlet was approximately 8 feet below the road surface. The inlet was not covered and was totally accessible. On the day of the incident, the flood

waters were approximately 10 feet deep at the inlet and were flowing in a northerly direction. With this amount of water, the pipe had a capacity of approximately 200 cubic feet per second and a velocity of approximately 15 feet per second. This drainage pipe was on a 6-year plan to be replaced with a larger capacity pipe and covered to prevent injury due to high flood water in that area. Work was expected to begin in year 2003. Since this incident, a junction box has been installed which covers the drain to the surface level.

Discussion: Before this incident, the city had received several complaints about the large amount of standing water and flooding in this area. The drainage pipe involved in this incident was originally installed in 1960 and measures 60 inches in diameter. It was on a 6-year plan to be replaced with a larger velocity pipe

(approximately 72 - 84 inches in diameter) and covered to prevent accidental injury during times of flooding. Work to replace this pipe was expected to begin in year 2003. Since this incident, a junction box and a trash grate have been installed to help prevent future injuries.

Recommendation #7: Municipalities should identify flood-related hazards and take steps to correct them as soon as possible in order to minimize potential for injury.
